*** Residential Inspection Report ***

1122 Broadway
Your Town, TX

PROPERTY INSPECTION REPORT

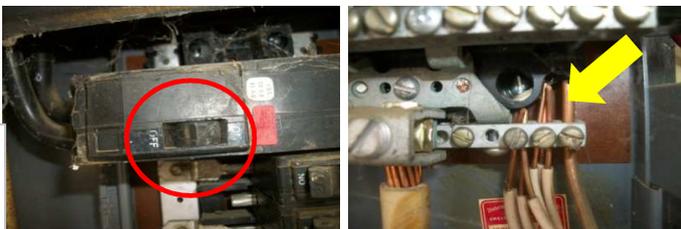
Comments:
 • The main disconnect circuit breaker is damaged and replacement is needed. This is considered a safety hazard and should be replaced as soon as possible. Refer to a qualified electrical contractor to make corrective repair.
 • Neutral wires are doubled or bundled together on the neutral bus bar. This is an unsafe condition that should be corrected by a qualified electrical contractor.

The breaker switch is

Service Entrance and Panels: • The main disconnect circuit breaker is damaged and replacement is needed. This is considered a safety hazard and should be replaced as soon as possible. Refer to a qualified electrical contractor to make corrective repair.

• Neutral wires are doubled or bundled together on the neutral bus bar. This is an unsafe condition that should be corrected by a qualified electrical contractor.

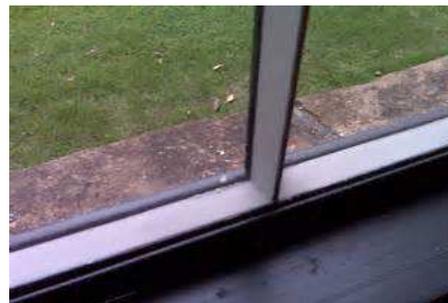
Type: • Aluminum (single pane)
 • Aluminum (dual pane)
 Comments: Cracked glass pane in family room, replacement needed.

Cracked glass pane

Windows: Cracked glass pane in family room, replacement needed.

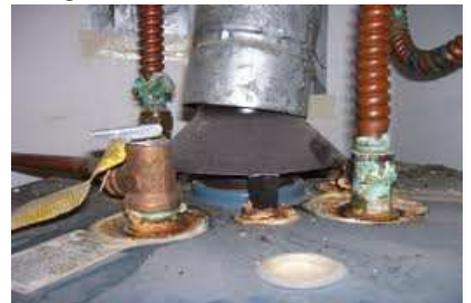
- Visible corrosion, this may be an indication of leakage, refer to a qualified professional for further evaluation and corrective repair(s) as needed.
- The exhaust vent pipe is loose and not properly secured to water heater, corrective repair needed.

Water heater

Heating system 1: • Visible corrosion, this may be an indication of leakage, refer to a qualified professional for further evaluation and corrective repair(s) as needed.

• The exhaust vent pipe is loose and not properly secured to water heater, corrective repair needed.
